The Municipal Building (City Hall)

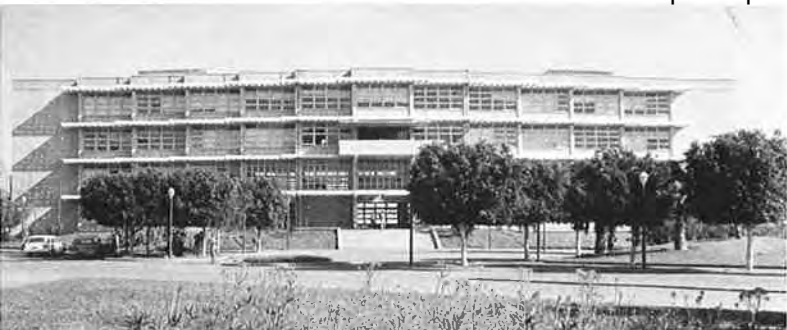
Fig. 52. Agadir Municipal Building, After the Earthquake

The view of the building shown in FIG. 52 gives the impression that the structure was not damaged by the earthquake. However, closer inspection revealed that non-structural damage (to partitions, interior plaster, windows, etc.) was very extensive, and that a significant amount of structural damage also occurred. FIG. 54 is a view of the front left part of the lobby of the

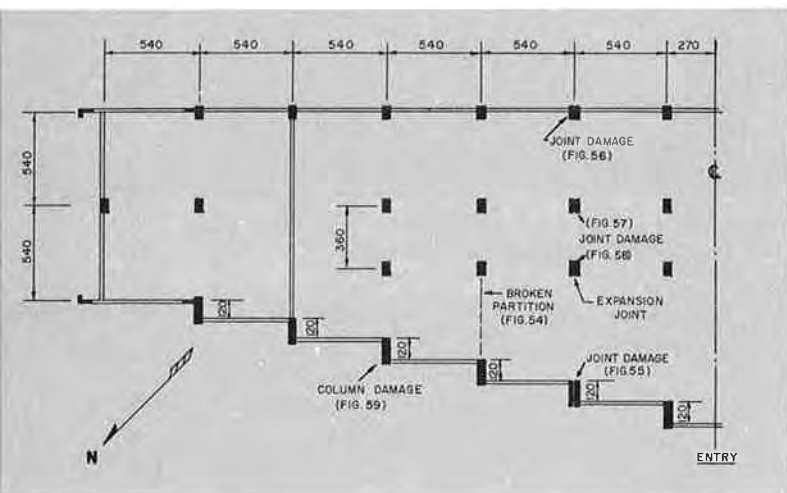
Fig. 53. Sketch of Column Layout, Municipal Building

The basic dimensions of the structure are shown in FIG. 53. It is apparent that the stepped pattern of the front of the building made it expedient to use columns which were rather deep in the NW-SE direction. Thus the building was quite resistant to lateral forces along this axis, which happened to coincide with the direction of the principal earthquake shock.

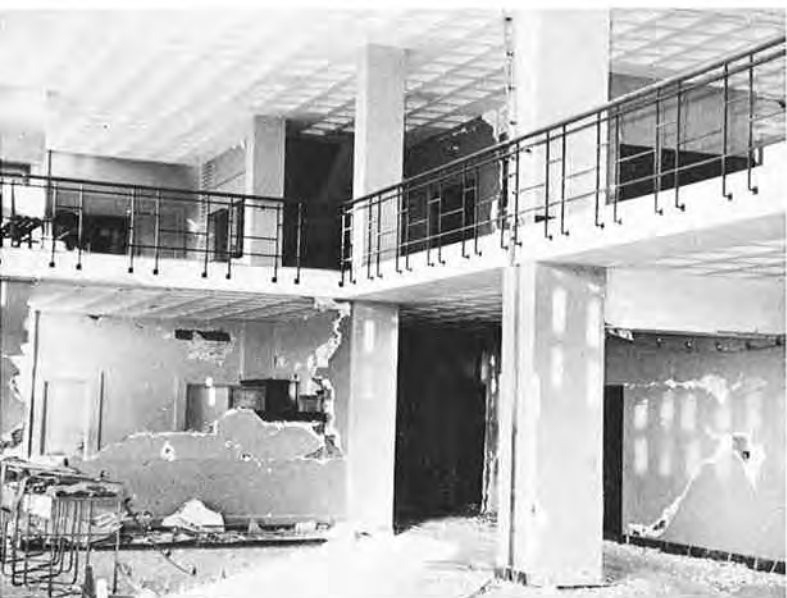
Fig. 54. Municipal Building, Damage to Tile Partitions

building, just inside the front doors. The clay tile partition which had spanned between columns at the left side of the photograph has been shattered because its rigidity greatly exceeded that of the columns. As the columns reacted to the lateral earthquake force (toward the left in this picture), they deflected, and the partition which was too stiff to accommodate this deflection (and too weak to support the earthquake force) ruptured. Damage to other interior partitions is also evident in this figure.

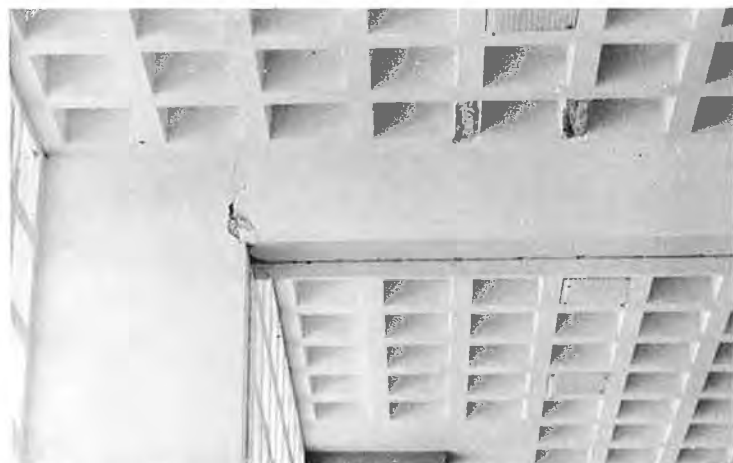
Fig. 55. Fracture of Girder-column Joint, Front Interior, Municipal Building

A typical example of the structural damage caused by the earthquake is presented in Fig. 55, which shows the girder-column joint located at the expansion joint at the front of the building (location noted in Fig. 53). Damage at the equivalent location to the rear of the building is shown in Fig. 56, and at the interior columns in Figs. 57 and 58. It is quite likely that part of the damage shown in Figs. 55 to 58 is due to relative movements of the structure on the two sides of the expansion joint. However, the principal point to be noted is that a relatively deep girder was provided between columns along the expansion joint, while at the other column lines the columns framed directly into the floor system. Thus, the effect of relative rigidities again is demonstrated. The frames along the expansion joint were stiffer than the other frames in the structure and were not able to accommodate as large displacements as the others. Damage to column joints were severe only at those locations where the girders were framed in. Where the column attached directly to the floor systems (providing greater flexibility), very little damage was observed. However, some evidence of working was apparent at the base of most of the columns, outside the structure, as shown in Fig. 59.

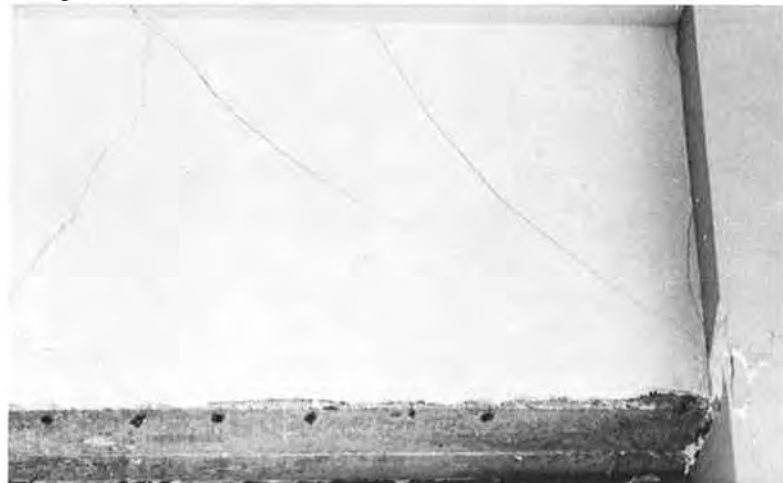
Fig. 57. Fracture of Joint at Interior Column, Municipal Building

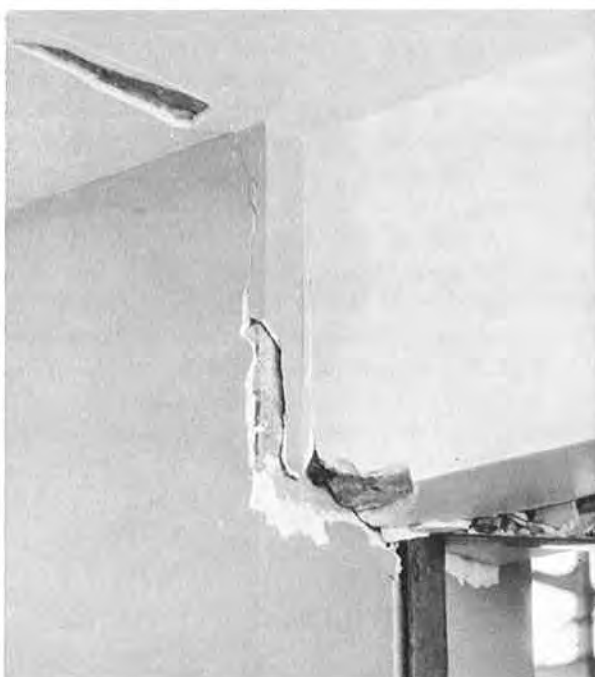
Fig. 58. Fracture of Joint at Interior Column, Municipal Building

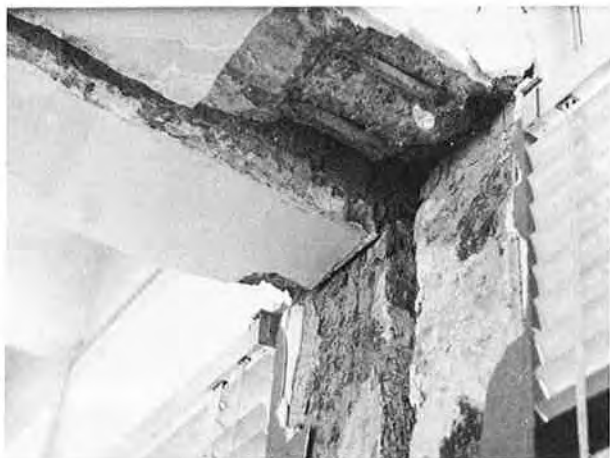
Fig. 56. Fracture of Girder-column Joint, Rear Interior, Municipal Building

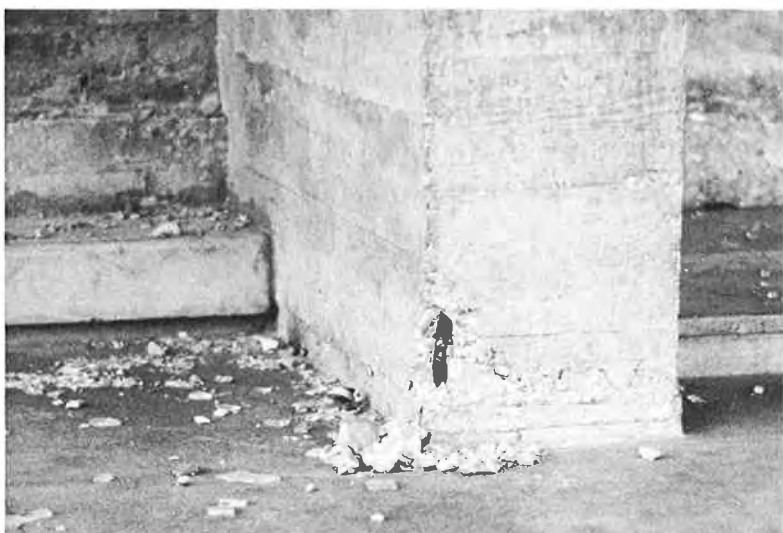
Fig. 59. Buckling of Reinforcement at Base of Column, Front Exterior of Municipal Building

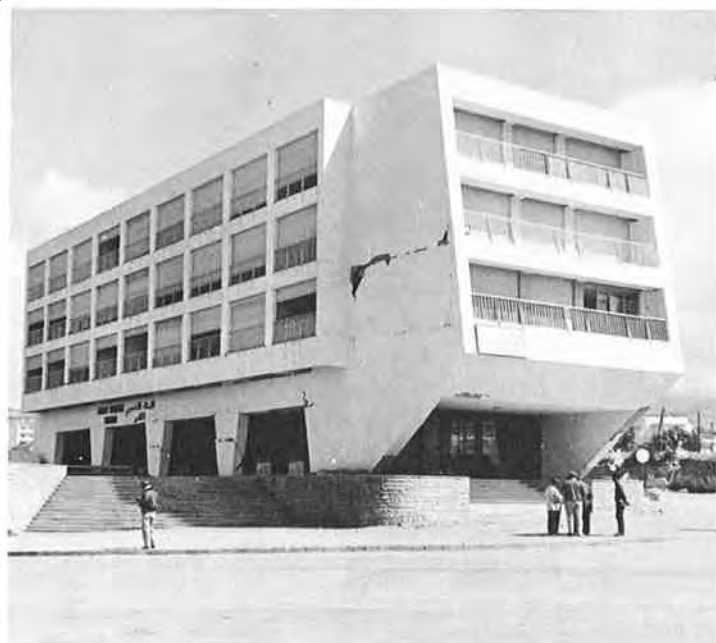
Another modern concrete frame structure of striking appearance is the Immeuble Paternel, shown in Fig. 60. This building housed the "Banque Populaire of Agadir" on the first floor, while the upper three stories were used for apartments. The concrete frame of this structure was severely damaged at the first floor level where the lateral force was resisted primarily by the exterior tapered columns. Two of the columns shown in Fig. 60 failed completely; Fig. 61 gives a closer view of one of these. The failure appears to be predominantly one of compression; reinforcing bars have buckled completely, with the result that the column is offset by more than an inch at each of two levels.

Fig. 60. Immeuble Paternelle in the New City, from the South

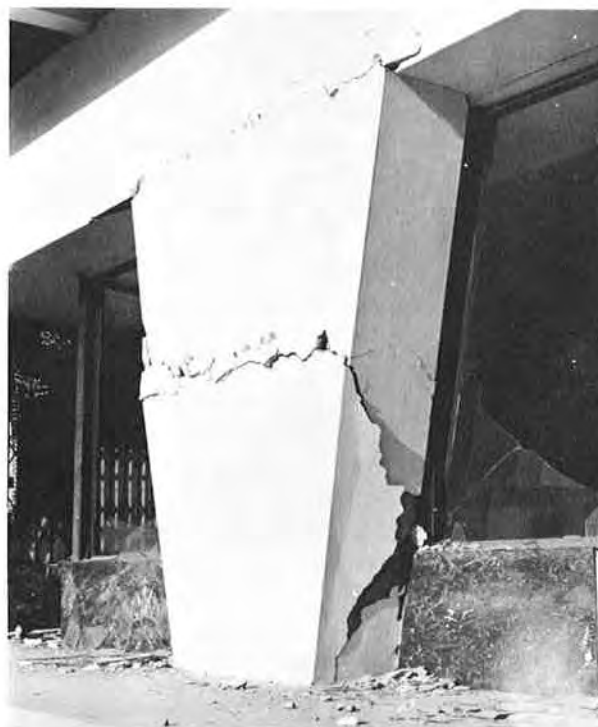
Fig. 61. Immeuble Paternelle, Detail of Column Fracture

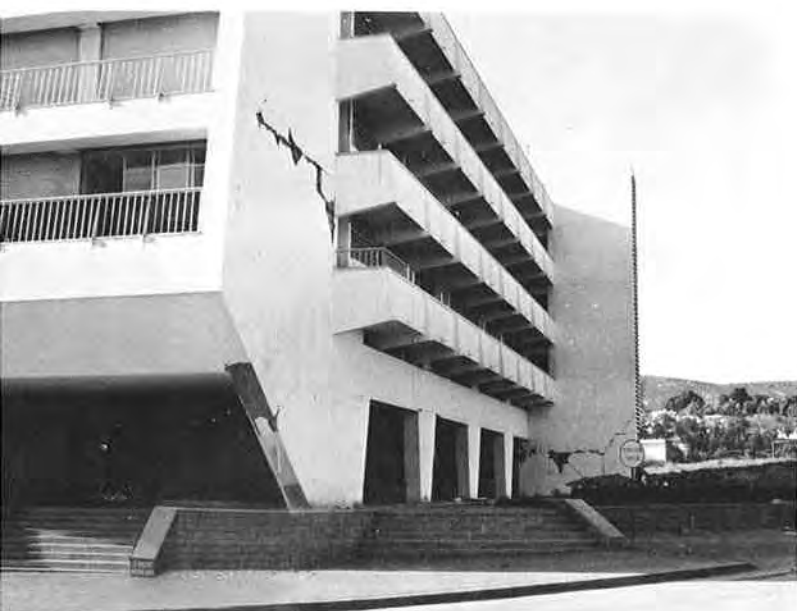
The cracking of the exterior filler wall in the projecting end of the building shows considerable working of the frame at the second floor level, the same type of damage being shown on the other side of the building as well (Fig. 62). Typical damage suffered by the interior partitions at the second floor level is shown in Fig. 63. It will be noted that the interior structural column in the center of the picture also had suffered appreciable damage.

Fig. 62. Immeuble Paternelle, from the Southeast

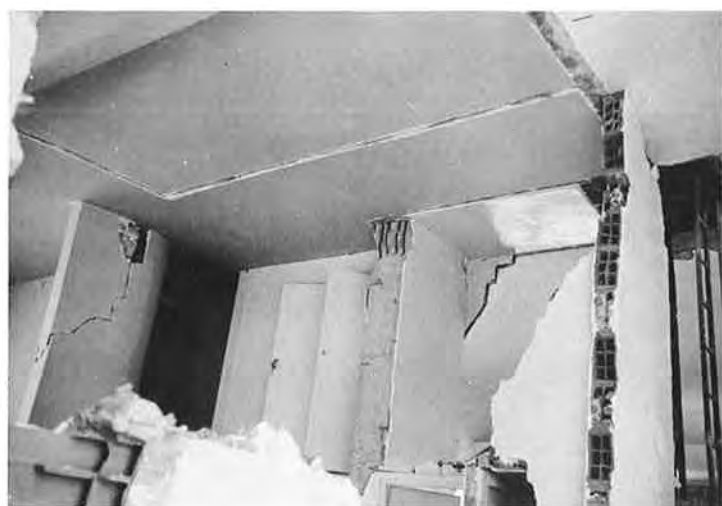
Fig. 63. Second Story Interior of Immeuble Paternelle, Showing Partition Damage

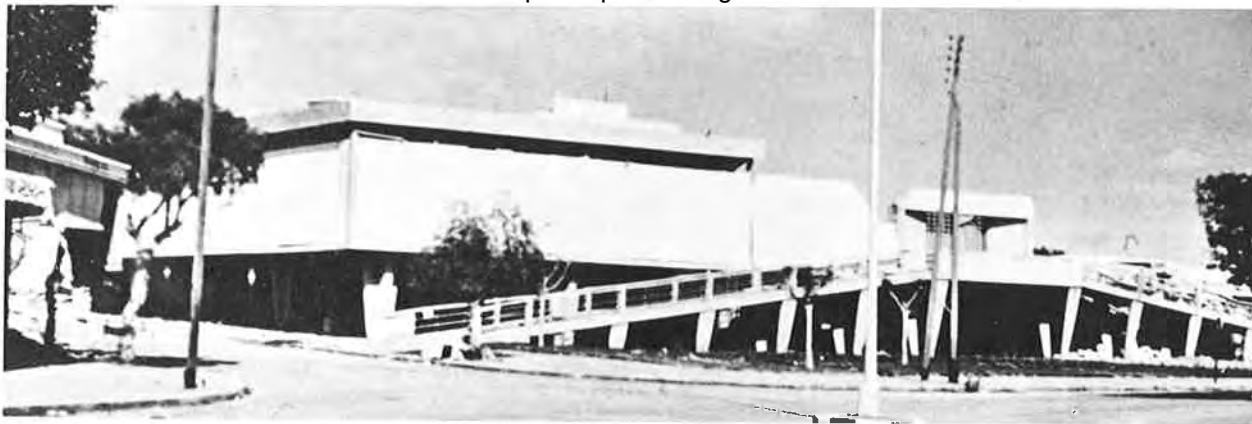
Fig. 64. New City Municipal Market

The market building of the New City, shown in FIG. 64, was also a concrete frame structure having moment resistant joints; but it did not perform as well during the earthquake as did the Municipal Building and the Immeuble Paternel. The first story of this building had very heavy concrete frames, designed to support heavy warehouse loadings of produce on the second floor. The roof of the upper story having a very light live load, however, was supported by rather slender columns. The entire structure was separated into three parts (each approximately 65 to 100 feet in plan) by expansion joints. The roof over two of these sections collapsed completely, while the third section was severely distorted as shown in FIG. 65. The collapse of these roof sections undoubtedly caused heavy vertical dynamic loadings on the unloaded floor system below, resulting in tremendous cracking and yielding of the slabs, joists, and frames as shown in FIG. 66. The earthquake itself, however, had practically no direct effect on the unloaded first floor structure, as was demonstrated by the excellent condition of the structure beneath the section of roof which did not collapse. The distortions which the lower story accommodated without collapse (FIG. 67) are of great interest in the design of earthquake resistant structures. A properly designed structure built of suitable materials can absorb a large amount of energy in plastic deformations; thus it is unrealistic to assume that a structure must behave elastically in the maximum "design earthquake." The manner in which this energy absorption concept has been incorporated into the most recent building codes will be discussed in Chapter 4 of this report.

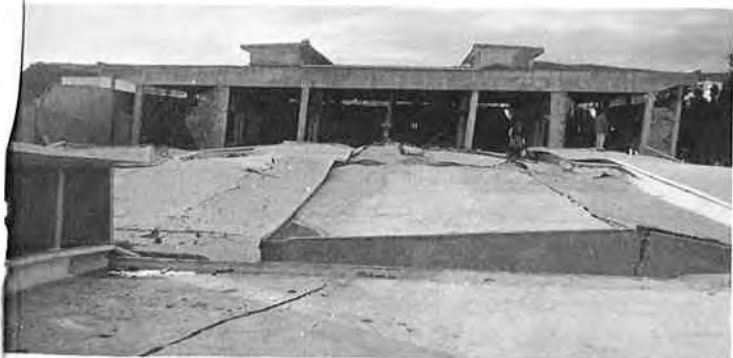
Fig. 65. Second Story of Market Building, Two Sections Collapsed, One Still Standing

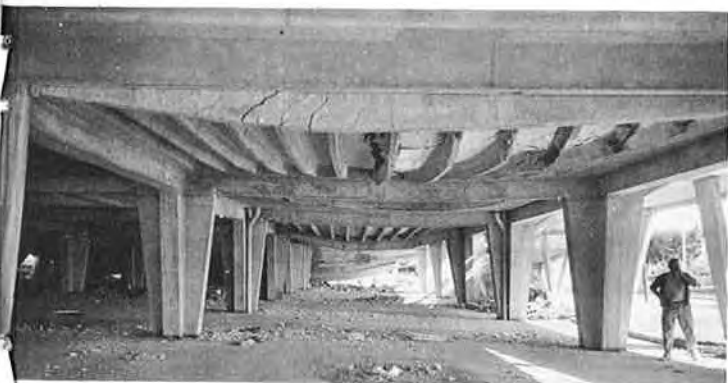
Fig. 66. Damage to Second Story Floor System of Market, Resulting from Collapse of Roof

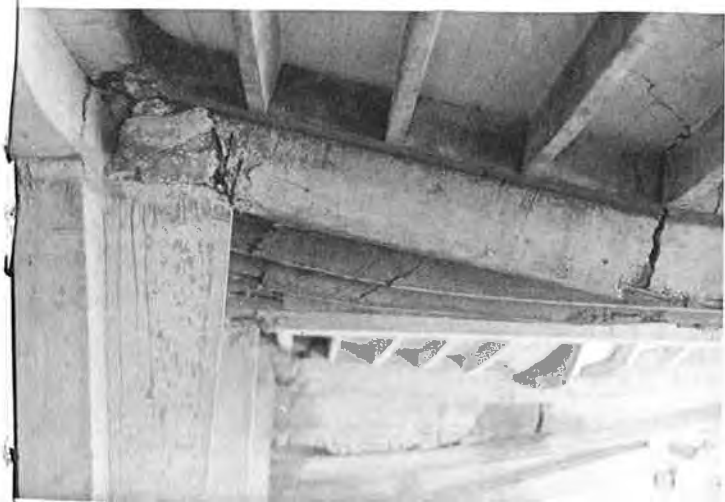
Fig. 67. Detail Demonstrating Large Yield Capacity of Market Frame Structure

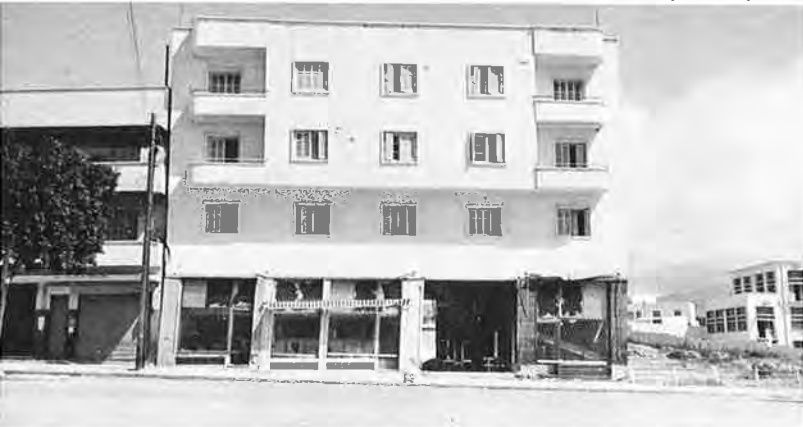
Fig. 68. Racking of Reinforced Concrete Columns

It may be instructive to consider a few other examples of structures having reinforced concrete frames. FIG. 68 shows a building which was located across the street from the Sud Building. It clearly shows the effect of the strong earthquake ground motion acting in the northwesterly direction. The reinforced concrete columns of the first story have been severely damaged at base and top. The lateral strength of the upper stories was greater than that provided by the first story columns, and all major damage was confined to the first floor level. The gap which has opened between this building and its neighbor to the left is of interest. There is no evidence of pounding between the two buildings, which indicates that there was no acceleration pulse of the ground toward the southeast to match the intensity of the pulse toward the northwest which opened the gap. Clearly this was an earthquake of short duration with only one or possibly two principal acceleration pulses.

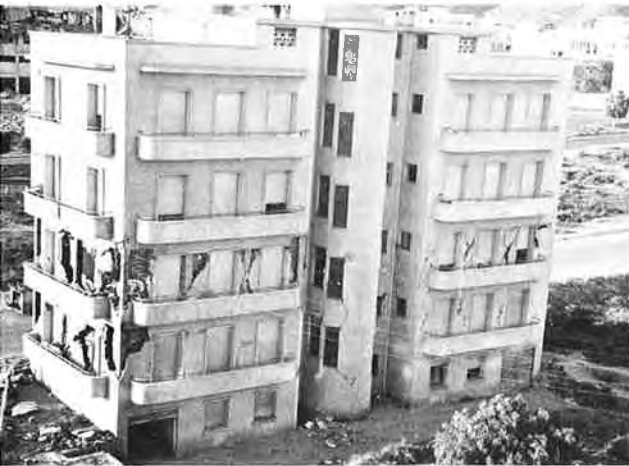
Fig. 69. Fracturing of Masonry Filler Walls Reveals Reinforced Concrete Frame

Other examples of the damage to reinforced concrete frame structures are shown in FIGS. 69 and 70, in which it will be noted how the damage generally was concentrated in the lower stories of the structure. Such results would be expected from an earthquake consisting of a single sharp acceleration pulse, because in such a case the total lateral force at any level depends primarily upon the mass of the structure above that level. The principal lateral strength of these structures was provided by the masonry filler walls; thus the strength was nearly constant over the height, and the failure, therefore, occurred in the zone of strongest forces. It is interesting to note in FIG. 69 how the masonry walls have cracked away (characteristic "x"-cracks), exposing the concrete skeleton which still supports the structure.

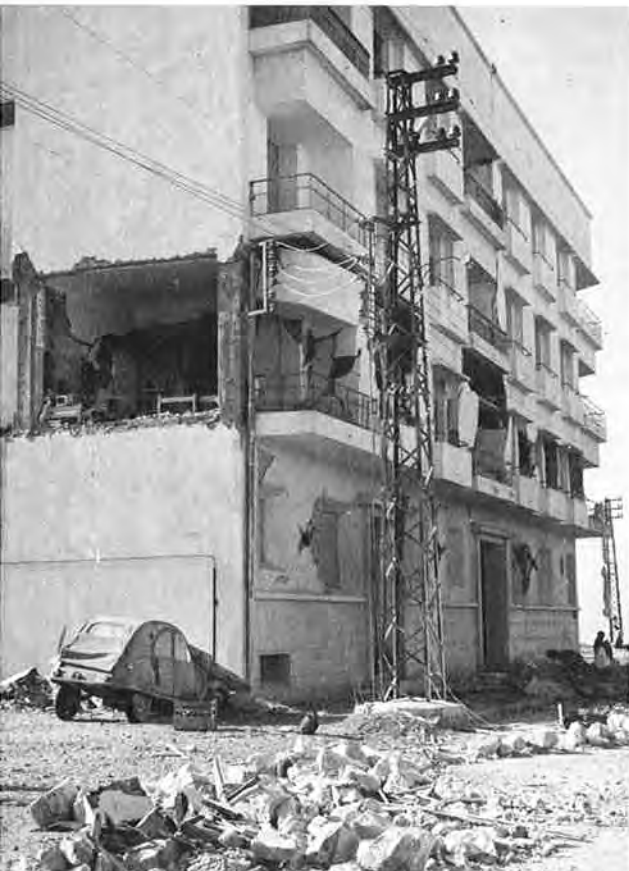
Fig. 70. Reinforced Concrete Frame Carries Load in Spite of Damage to Masonry
