SPECIAL STRUCTURES

"La Reserve" Restaurant

PORT FACILITIES

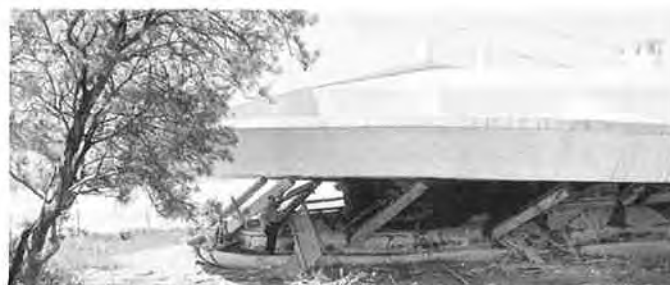
The restaurant "La Reserve" had a very attractive location on the beach at Agadir, and the architect developed an unusual style of structure well adapted to its location (Figs. 71 and 72). The plan form of the structure consisted of three intersecting circles, each about 35 feet in diameter, with their centers located at the apexes of an equilateral triangle about 30 feet on a side. The deck of the structure was supported at a height of about 12 feet by a tapered column under the center of each circular segment of the structure. The lateral strength of this structure was controlled by the bending and shear capacity of these columns with no other bracing being provided. The complete collapse of the structure, which could have been anticipated, is shown in Figs. 73 and 74. Some indication of the mechanism of failure is provided by Fig. 75. At the left side of this photograph can be seen the upper part of one of the supporting columns which has punched through the base slab of the structure.

Fig. 73. "La Reserve" Restaurant From the East, After the Quake

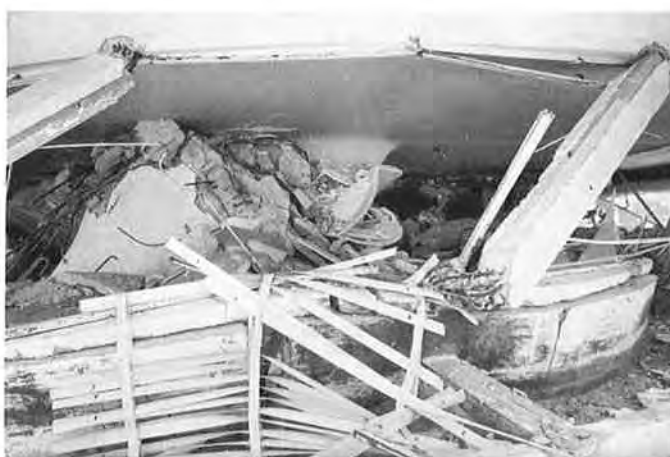
Fig. 74. General View of the Collapsed "La Reserve" Restaurant

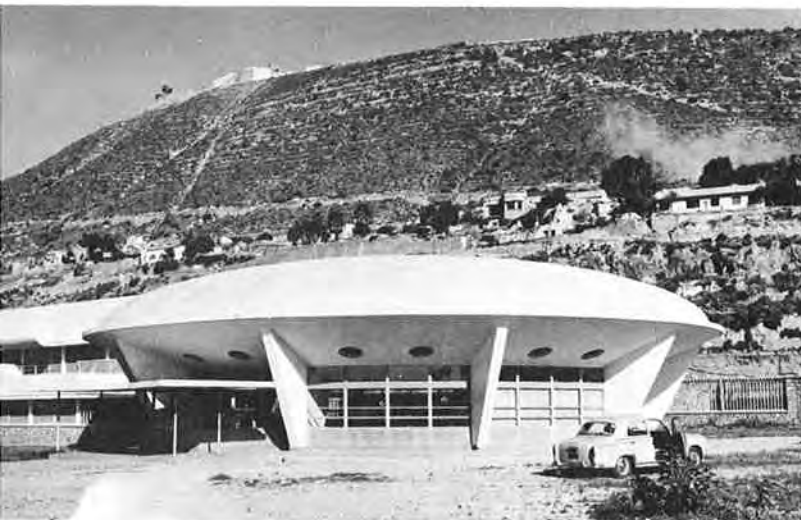
Fig. 75. Detail of the Collapse, Showing How Columns Have Punched Through the Floor System

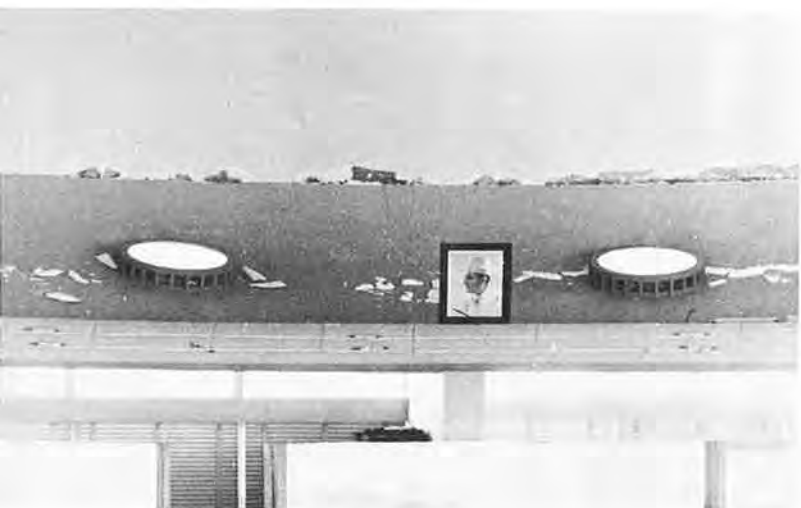
Fig. 76. The Customs House in the Port Area, After the Earthquake

Another unusual structure was the customs house (FIG. 76) which was located adjacent to the port. This 80-foot diameter reinforced concrete shell structure supported by many large tapered columns, performed very well during the earthquake. An interior view of the joint between the outward sloping wall of the structure and the dome roof is shown in FIG. 77. Considerable working of this joint is evident, and there is some indication of cracking in the outward sloping wall, but the system remains structurally intact. This structure was constructed in an area of filled ground, and was supported on concrete piles driven to solid rock at a depth of 25 to 30 feet. Evidence of settlement of the fill with respect to the pile-supported structure is shown in FIG. 78. Also shown is some cracking at the base of one of the columns supporting the roof system. Several columns showed such cracking, but it was not considered indicative of significant structural damage.

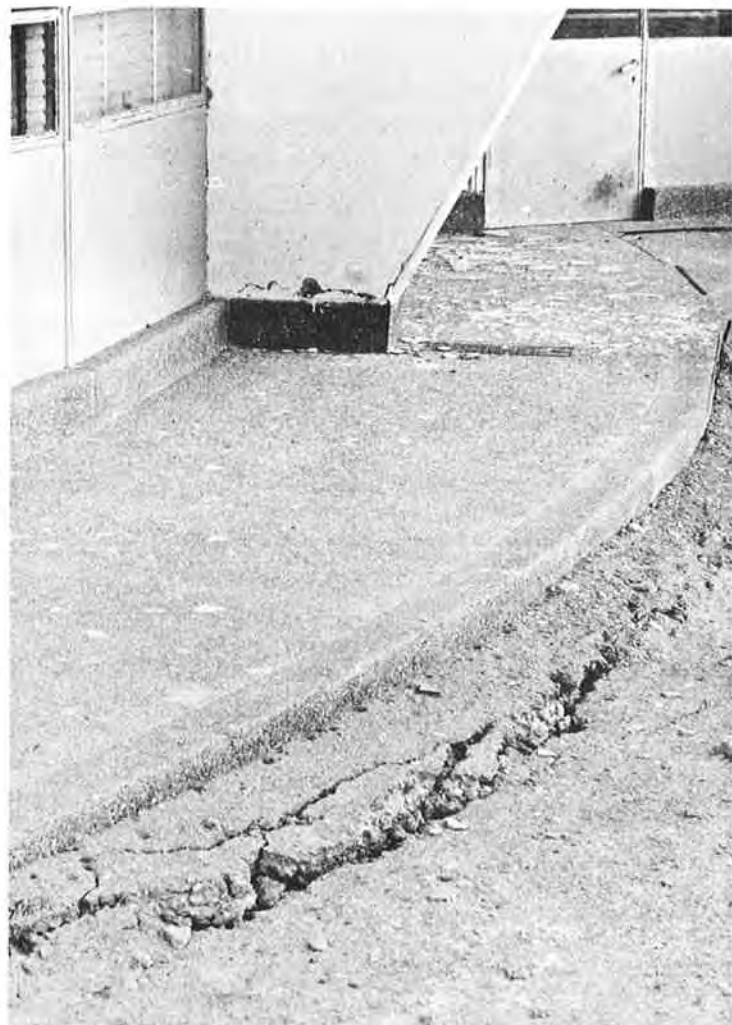
Fig. 77. Interior View of Customs House, Showing "Working" of Joint Between Walls and Dome Roof

Fig. 78. Cracking at Base of Column of Customs House; Note Settlement of Soil With Respect to Structure

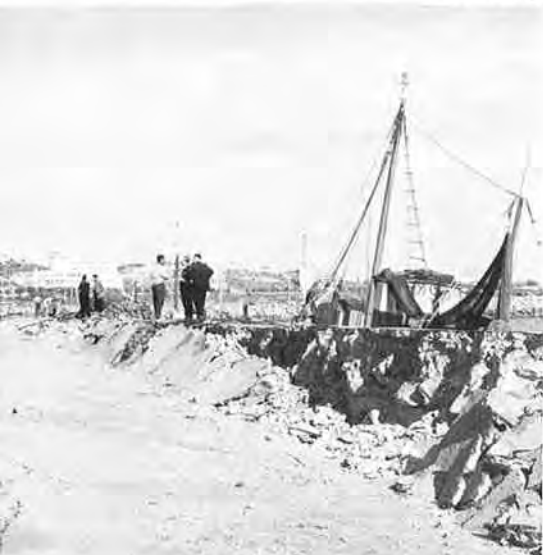
Fig. 82. Subsidence of Fill Adjacent to North Quay Wall

The primary cause of earthquake damage on the port area was a general subsidence of this fill material. According to the Port Engineer, Mr. Bouayad, the fill was placed by dumping large rocks first and then filling over these with successive layers of smaller rocks, finishing with a layer of earth. Apparently the fill material was not compacted thoroughly during construction. Consequently, the heavy earthquake vibrations caused the finer material to sift down into the voids in the coarse material, resulting in very large settlements over the entire fill zone. FIG. 82 shows the extent of the settlement in an area where it approached the maximum. The subsidence was quite uniform over a large area, so that the surface of the filled area remained flat; however, the concrete quay wall which was supported on a solid foundation did not settle, and the vertical extent of the fracture line between the concrete wall and the fill is quite impressive.

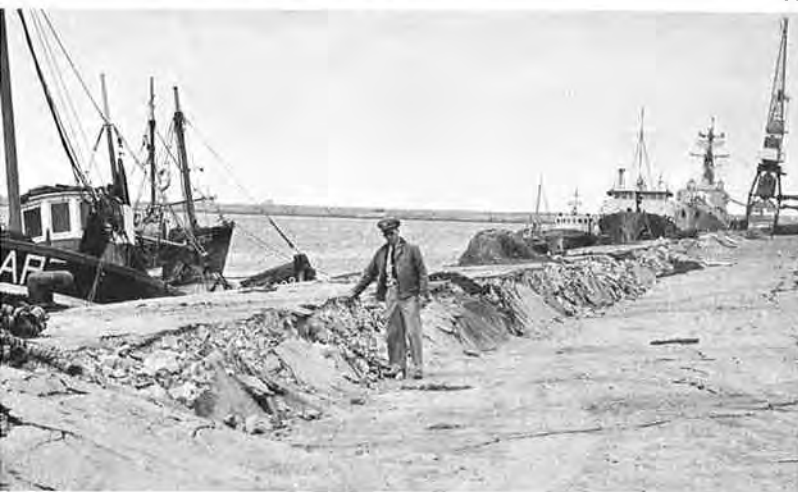
Fig. 83. Subsidence of Fill Adjacent to North Quay Wall

Similar relative settlements between quay wall and fill were noted all around the periphery of the harbor basin. Relatively little harm resulted in most locations as shown by FIGS. 83 and 84. However, rails for the operation of 6-ton portal cranes were located along the dock sides in front of the warehouses. With one crane

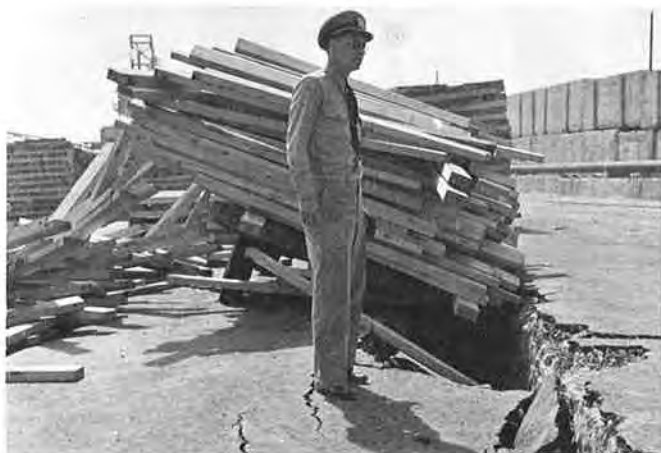
Fig. 85. Effects of Fill Subsidence, Along Crane Rail System, North Quay Wall

rail placed on the concrete quay wall and the other on the fill (FIG. 85) the settlement of the fill material caused a tilting of the cranes. Of the seven cranes operating on these tracks (4 on the north dock, 3 on the south) five toppled over as a result of the fill subsidence (FIG. 86) and the two which remained standing were tilted too far to be used with safety (FIG. 87). The smaller cranes on the west dock areas were affected similarly (FIG. 88).

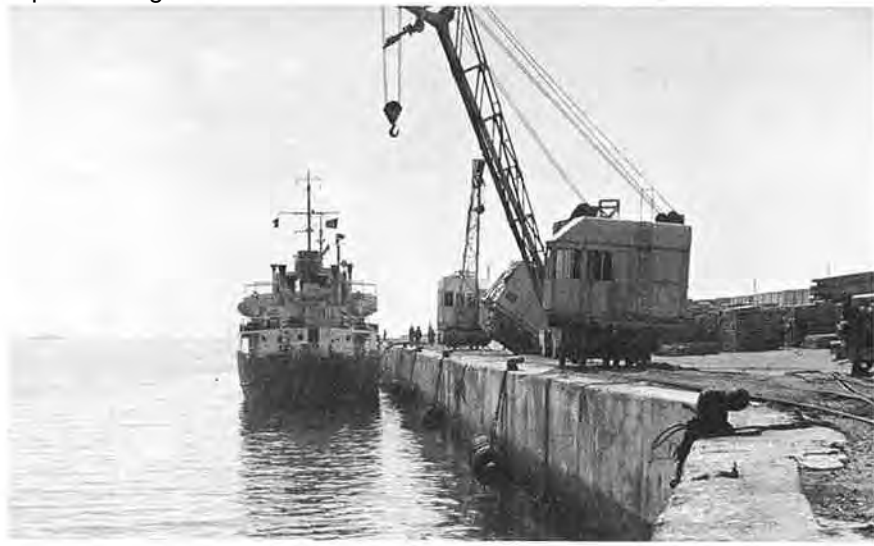
Fig. 88. Crane Upset Along West Quay Wall

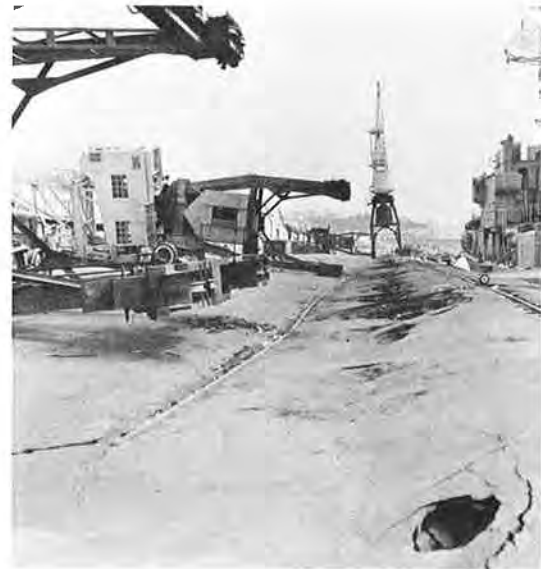
Fig. 87. Tilting of Crane, North Quay Wall

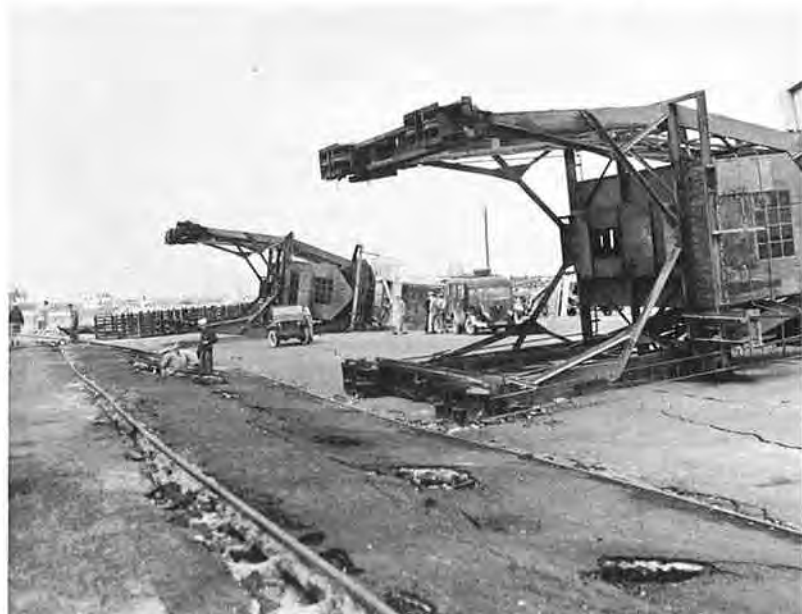
Fig. 86. Cranes Overturned by Fill Subsidence, North Quay Wall

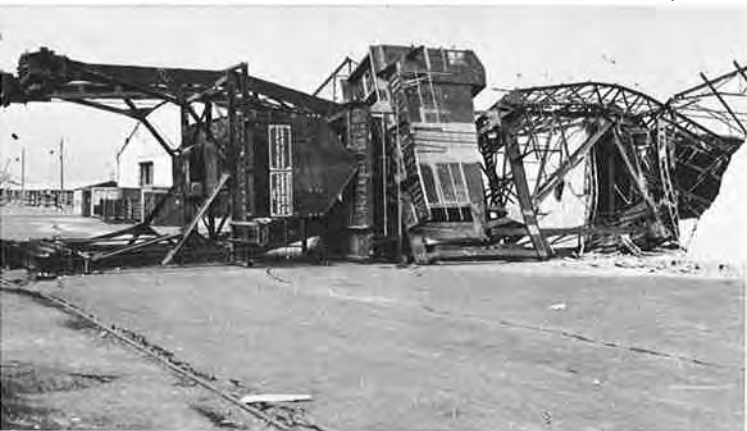
Fig. 89. Warehouse Building Crushed by Overturning of Crane

The principal structural damage in the port area was a secondary result of the soil subsidence. Two of the cranes which toppled over dropped on the steel frame warehouse buildings, causing complete local collapse (FIGS. 89 and 90). Except for these local effects, however, these lightweight, well-braced structures were practically unaffected by the earthquake. An adjacent open, steel-frame shed settled slightly on the subsiding fill material (FIG. 91), but showed no vibrational damage.

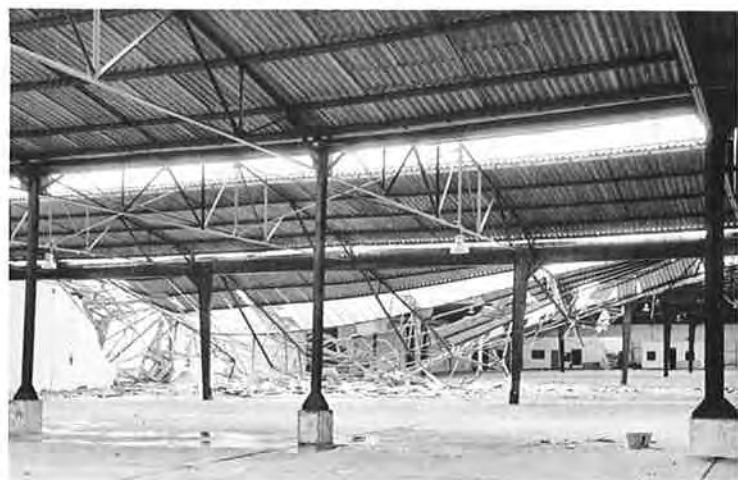
Fig. 90. Interior of Warehouse Crushed by Crane

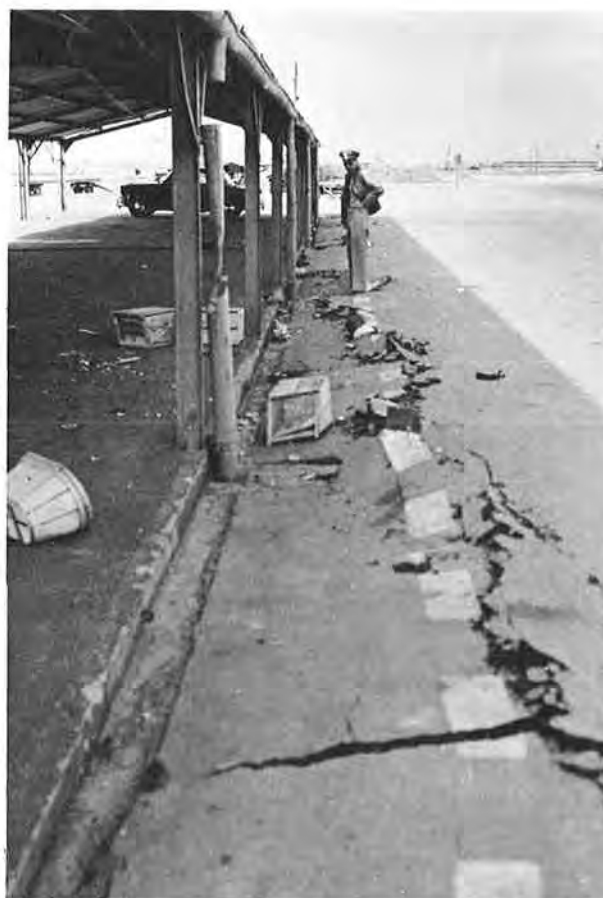
Fig. 91. Settlement of Steel Frame Shed Structure
