SPECIAL STRUCTURES

"La Reserve" Restaurant

PORT FACILITIES

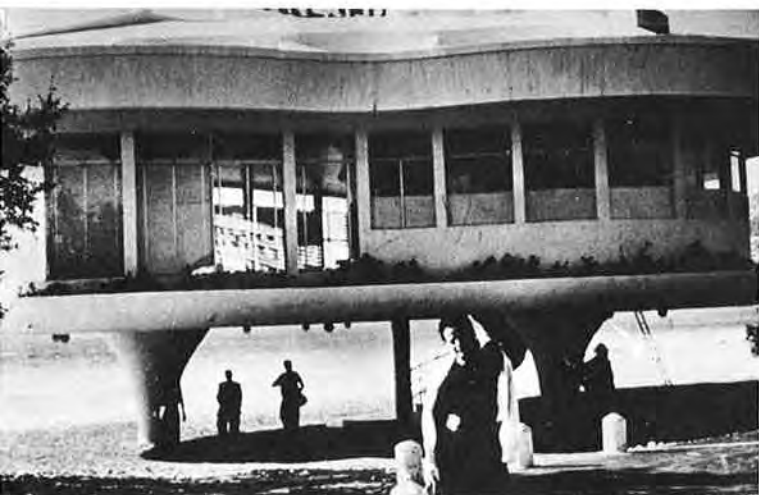
Fig. 71. "La Reserve" Restaurant From the East, Before the Earthquake

The restaurant "La Reserve" had a very attractive location on the beach at Agadir, and the architect developed an unusual style of structure well adapted to its location (Figs. 71 and 72). The plan form of the structure consisted of three intersecting circles, each about 35 feet in diameter, with their centers located at the apexes of an equilateral triangle about 30 feet on a side. The deck of the structure was supported at a height of about 12 feet by a tapered column under the center of each circular segment of the structure. The lateral strength of this structure was controlled by the bending and shear capacity of these columns with no other bracing being provided. The complete collapse of the structure, which could have been anticipated, is shown in Figs. 73 and 74. Some indication of the mechanism of failure is provided by Fig. 75. At the left side of this photograph can be seen the upper part of one of the supporting columns which has punched through the base slab of the structure.

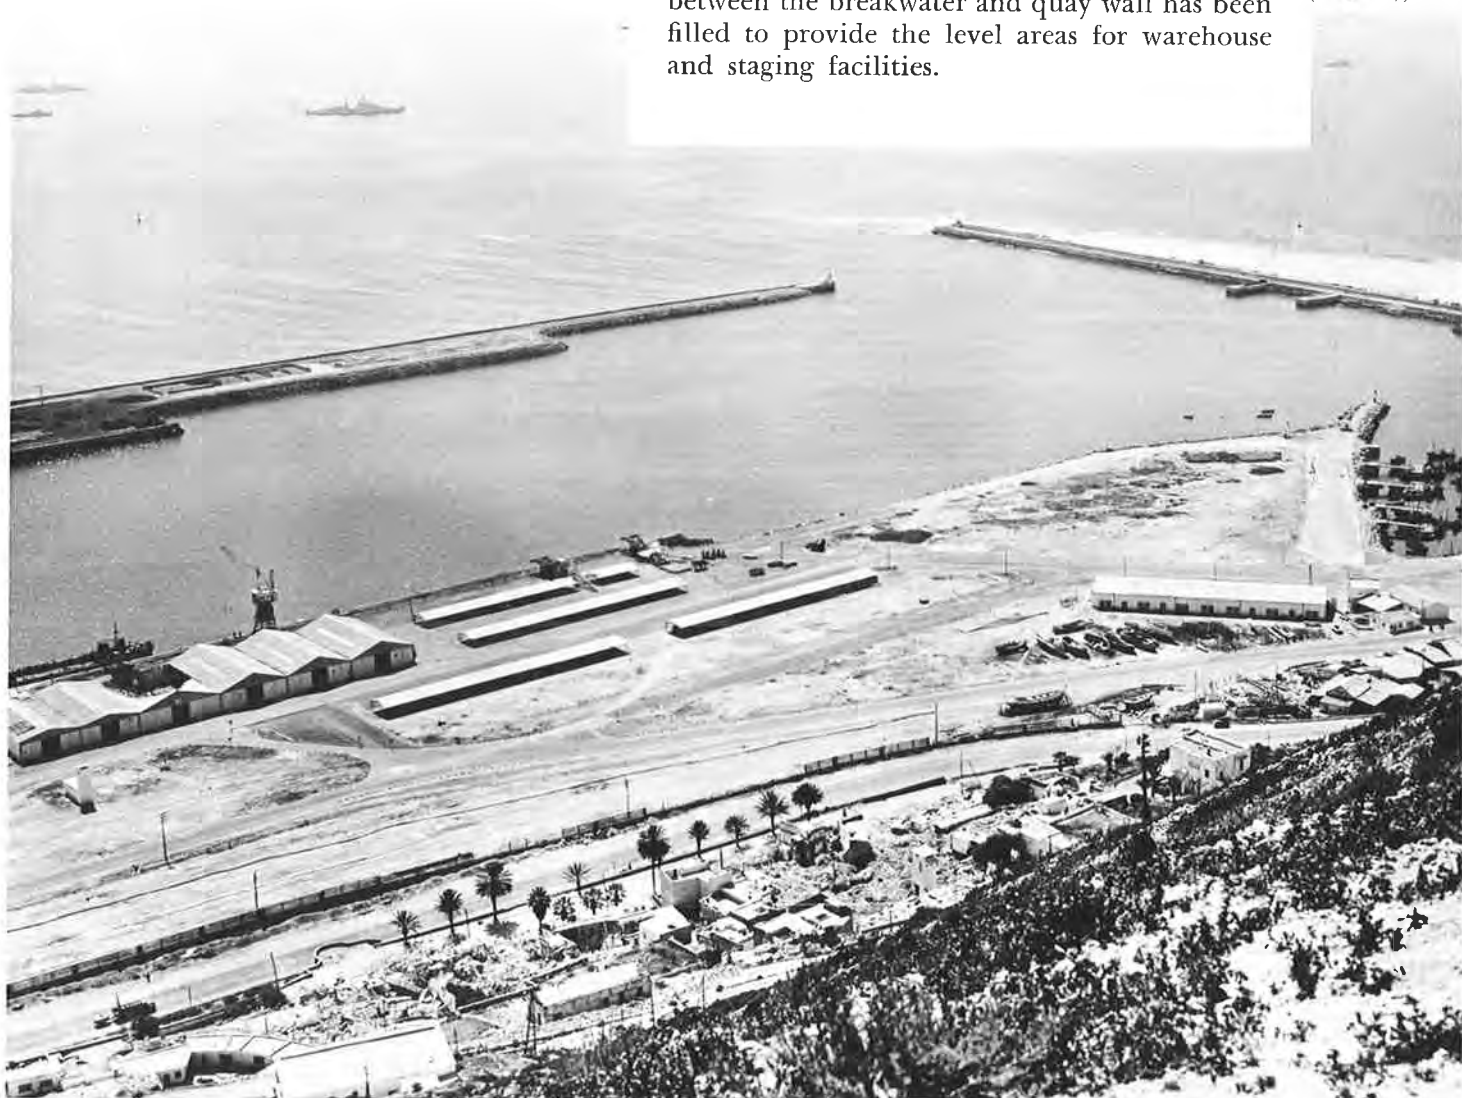
Fig. 79. View of Agadir Harbor from the Kasbah Hill

The harbor consists of a shore line pier enclosed on the south and west sides by two breakwaters. A general view of the port area is shown in FIG. 79, a photograph which was taken from near the crest of the Kasbah hill. The inner harbor area is shown in FIG. 80, and a sketch of the harbor facility is presented in FIG. 81. The general form of construction consists of a rubble breakwater to the seaward side and a concrete quay wall on the docking side. The zone between the breakwater and quay wall has been filled to provide the level areas for warehouse and staging facilities.
